# CASE STUDY

## ADVANCED PULLING TECHNOLOGY

INDUSTRY: Oil and Gas  
PROJECT: Free Standing Liner Rehabilitation

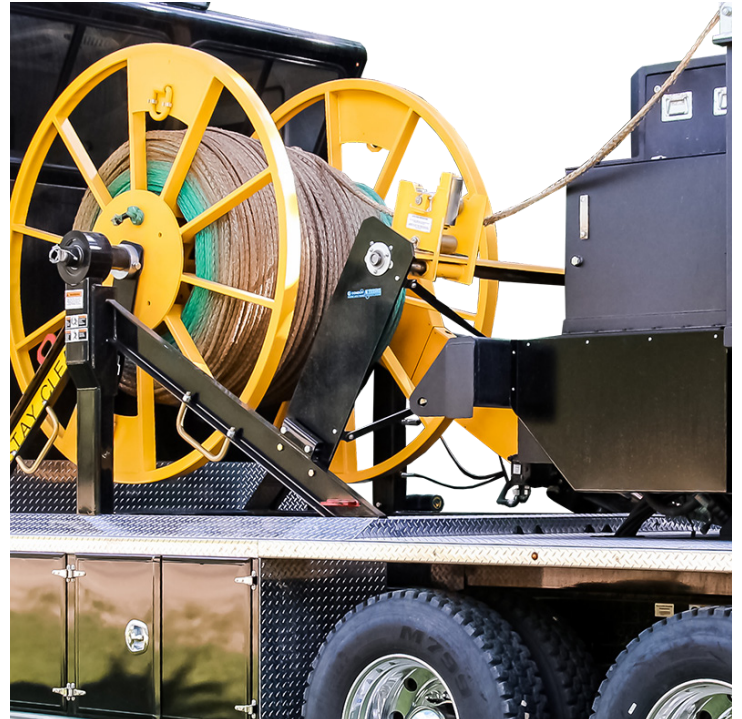
Canline deployed one of its state-of-the-art Advanced Pulling Technology (APT) units to the site. All APT units are equipped with Real Time Data Acquisition Equipment that monitors and records speed, weight, and distance in a Data Logging Record (DLR). The APT's direct drive hydraulic capstan system, allows for smooth, consistent pulling power, making it far superior to conventional "wire-line" trucks. This unit also features specialized, lightweight, high performance, synthetic rope. It is extremely strong, flexible, and safer than steel cable, which has an incredible amount of stored energy when it is under tension. The use of synthetic, lightweight rope, allows for longer pulls and mitigates the potential for internal damage to the pipeline, especially where there are bends. The installation was completed on July 7th, 2020, without issue.
